#### **INVENTORY & CHECK OUT REPORT**

4<sup>TH</sup> SEPTEMBER 2015 – 5<sup>TH</sup> SEPTEMBER 2016

CHECK-IN SUMMARY FOR				
ADDRESS DELETED				
GENERAL CONDITION		Property has been professionally cleaned	ed.	
CARPET/FLOORS		X3 tiles cracked in bathroom. X1 scuff mark to flooring in reception.		
WALLS/SKIRTING/WOODWORK		Light scuff & usage marks to wall throughout. Patchy paintwork visible. Repair marks visible to walls in reception, bedroom & kitchen & entrance hallway.		
WINDOWS		Cracking visible to bottoms of frames throughout. X1 pane cracked in bedroom.		
CURTAINS/BLINDS		All WO when tested.		
KITCHEN APPLIANCES/UNITS/WORK	TOPS	Have been professionally clean. Drip marks between glass panes of oven door. Staining visible underside of worktop. Heavy cracking visible to sink.		
BATHROOM(S)		Bathroom & bathroom fittings have been professionally cleaned. Small chip visible to toilet cistern. Shower mixer tap heavily tarnished.		
GARDEN / BALCONY		N/A		
ELECRTRICITY		Located in communal hallway cupboard.  Meter 1 - Reading: 08588.9 Serial Number: K83A 05347 Meter 2- Reading: 71567 Serial Number: K72A 06178

CHECK-OUT SUMMARY FOR				
	ADDRESS DELETED			
GENERAL CONDITION		Property

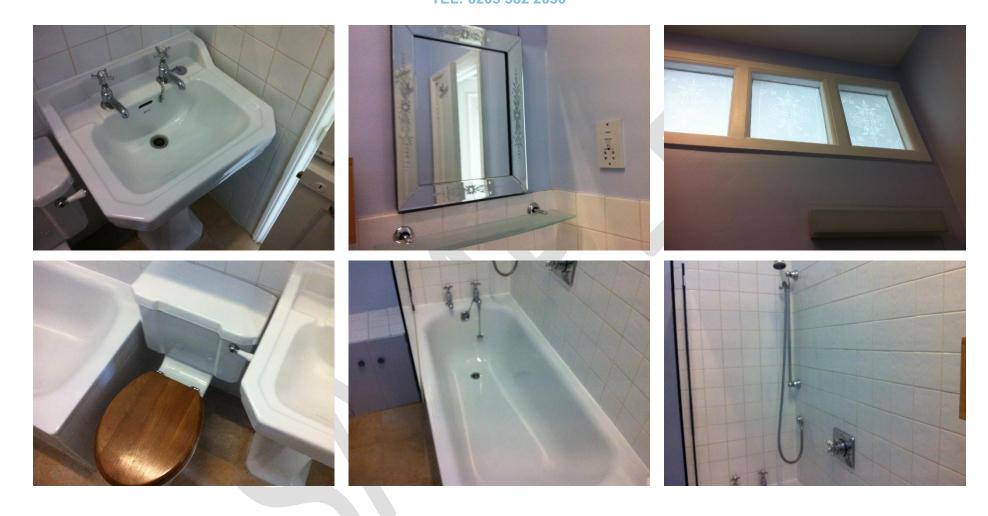
### All Check In Pictures Taken On The 4th September 2015

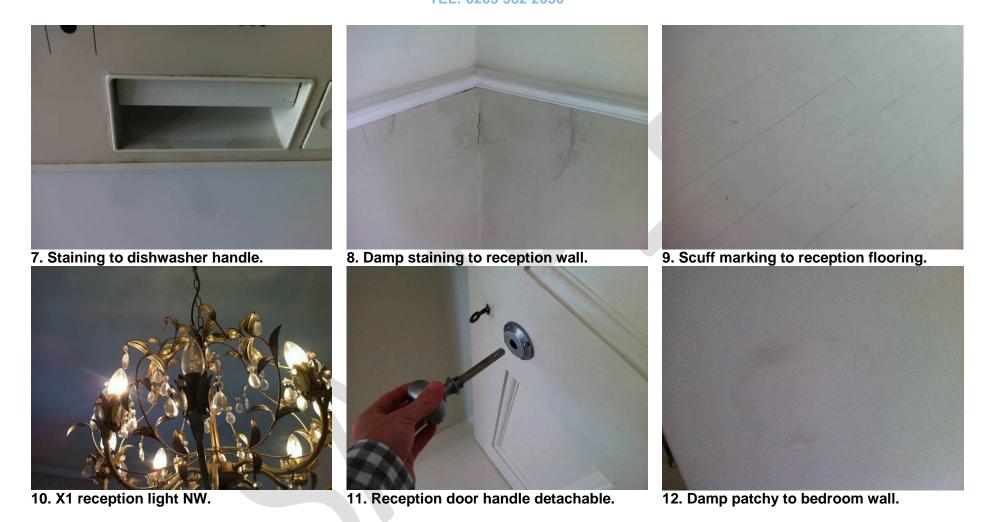
E.g. Pictures Only Further Pictures Inc. Defect Pictures Kept On File & Available On Request.
